# Title: Air Handling Unit

Industry: Pharmaceutical | Machine: Air Handling Unit | Technology: Vibration Analysis

**Purpose:** This case study highlights testing performed on an air handling unit needed to run two supply fans at capacity in support of air flow requirements for enclosed areas within a pharmaceutical facility.

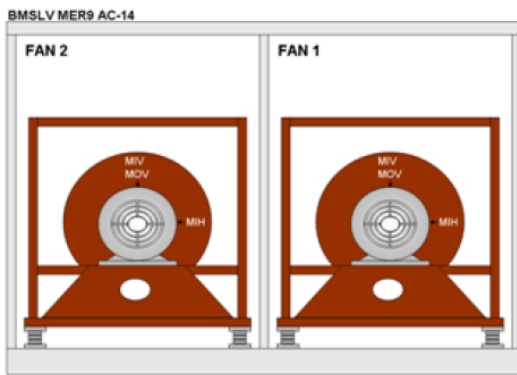
VIBRATION TEST RESULT (RUNNING THE FAN ONE AT A TIME)

MEASUREMENT POINT	VFD SPEED	SUPPLY FAN # 2	SUPPLY FAN # 1
MOV MOTOR OUTBOARD VERTICAL	55.6 HZ	OFF	.190 In/Sec
MV MOTOR INBOARD VERTICAL	55.6 HZ	OFF	.127 In/Sec
MH MOTOR INBOARD HORIZONTAL	55.6 HZ	OFF	.068 In/Sec

MEASUREMENT POINT	VFD SPEED	SUPPLY FAN # 2	SUPPLY FAN # 1
MOV MOTOR OUTBOARD VERTICAL	59.9 HZ	.240 In/Sec	OFF
MV MOTOR INBOARD VERTICAL	59.9 HZ	.091 In/Sec	OFF
MH MOTOR INBOARD HORIZONTAL	59.9 HZ	.081 In/Sec	OFF

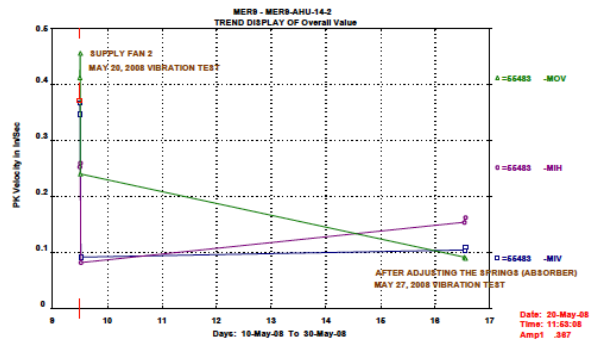
VIBRATION TEST RESULT (May 27, 2008)

1ST READING	SUPPLY FAN 2				SUPPLY FAN 1			
POINT	SPEED	OPEN	AMPS	VIBE	SPEED	OPEN	AMPS	VIBE
MOV	63 HZ	45%		0.09 In/s	63 HZ	45%		0.37 In/s
MIV	63 HZ	45%		0.15 In/s	63 HZ	45%		0.24 In/s
MIH	63 HZ	45%		0.10 In/s	63 HZ	45%		0.25 In/s
REMARK	AFTER ADJUSTING THE SF2 SPRINGS

3RD READING	SUPPLY FAN 2				SUPPLY FAN 1			
POINT	SPEED	OPEN	AMPS	VIBE	SPEED	OPEN	AMPS	VIBE
MOV	63 HZ	50%	107 A	0.08 In/s	63 HZ	70%	131 A	0.46 In/s
MIV	63 HZ	50%	107 A	0.16 In/s	63 HZ	70%	131 A	0.25 In/s
MIH	63 HZ	50%	107 A	0.10 In/s	63 HZ	70%	131 A	0.14 In/s
REMARK	AFTER ADJUSTING THE SPRINGS

2ND READING	SUPPLY FAN 2				SUPPLY FAN 1			
POINT	SPEED	OPEN	AMPS	VIBE	SPEED	OPEN	AMPS	VIBE
MOV	63 HZ	50%		0.08 In/s	63 HZ	50%		0.46 In/s
MIV	63 HZ	50%		0.16 In/s	63 HZ	50%		0.25 In/s
MIH	63 HZ	50%		0.10 In/s	63 HZ	50%		0.15 In/s
REMARK	AFTER ADJUSTING THE SF2 SPRINGS

4TH READING	SUPPLY FAN 2				SUPPLY FAN 1			
POINT	SPEED	OPEN	AMPS	VIBE	SPEED	OPEN	AMPS	VIBE
MOV					58 HZ			0.29 In/s
MIV					58 HZ			0.24 In/s
MIH					58 HZ			0.11 In/s
REMARK	NOT RUNNING				AFTER ADJUSTING THE SPRINGS

**Analysis:** The first vibration reading showed a significant decrease of amplitudes on supply fan #2 after adjusting its six spring absorbers, most notably from 0.45 in/s to 0.09 in/s on point MOV. However, when the damper positions of the two fans were opened 45%, 50%, and 70%, the amplitudes on supply fan #1 started to increase while the amplitudes on supply fan #2 remained steady. Subsequent readings showed reduced vibration levels on supply fan #1 when supply fan #2 was turned off. Additional bump tests and analysis were performed to look for natural frequencies that would interfere with the normal operation of the fan. No significant issues were noted.

**Findings:** The spring absorber loading and damper positions played a significant role in vibration levels. Most of the springs needed to be properly adjusted and any damaged ones were scheduled for repair or replacement. Once the the springs were no longer an issue, it was determined that if abnormal levels are present during future readings, the damper position should be noted and addressed if it's more than transient in nature.
