Title: Fluting Case Study: Variable Frequency Drive on Motor

Industry: Paper | Machine: Paper Machine – Fan Pump | Technology: Vibration Analysis

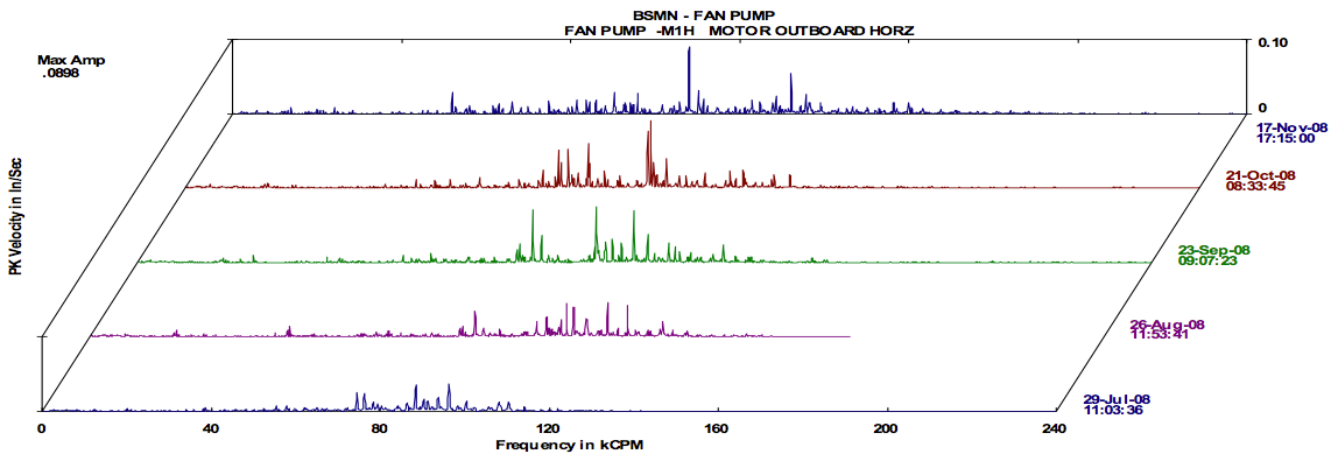
Findings: Over the course of a few months, we watched the progressing of motor bearing faults on the fan pump caused by ‘fluting.’ The progression is best seen in the acquired high-frequency spectral data plot diagram below.

Analysis: The spectral data shows high-frequency energy seen as a 'haystack' out past 80 Kcpm associated with high Gs in the time-waveform. The historical trend of the high-frequency band is at a steady incline indicating that the condition is worsening. Electrical potential or "charge" builds up on the shaft and discharges through the bearing(s). This is known as 'fluting' due to the excessive noise associated with this problem.

Recommendation: It is recommended to have both motor bearing replaced. At the time of the bearing replacement, install a shaft grounding device to eliminate the "fluting" from reoccurring. (The motor was swapped with a spare rebuilt motor with the shaft grounding rings installed at the motor shop shortly after this collection).

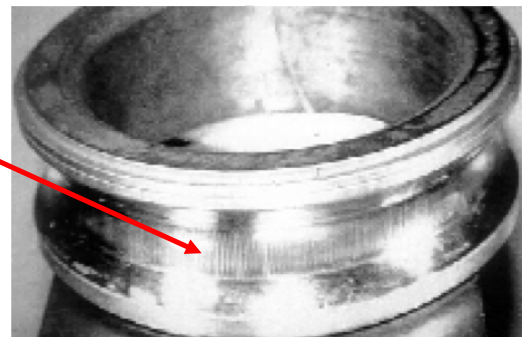
Here is a visual example of inner race etching caused by shaft current discharged through the bearing.
