Title: Air Handling Unit

Industry: Pharmaceutical | Machine: Air Handling Unit | Technology: Vibration Analysis

Purpose: This case study highlights testing performed on an air handling unit needed to run two supply fans at capacity in support of air flow requirements for enclosed areas within a pharmaceutical facility.

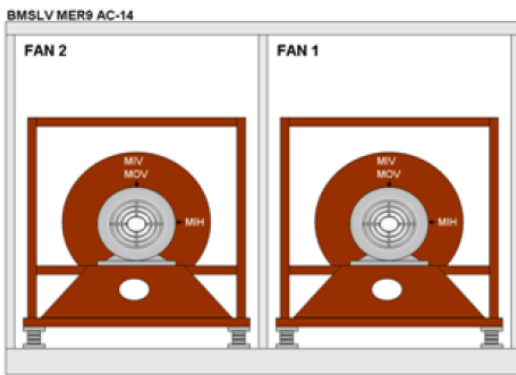
Overview: The site was in the process of commissioning an air handling unit (AC-14) to support and meet the air flow requirement of the enclosed areas which needed to be on-line. The unit had two direct-coupled fans each with a 150-hp motor. The unit appeared to be fine when running one fan, but when the second fan was also running, at certain set points, vibration issues occurred.

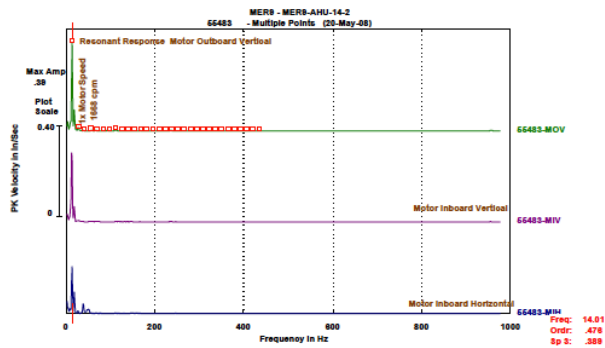
Analysis: When each fan was tested one at a time, fan #1 and #2 both showed notable low levels of vibration amplitudes across the motor (Table 1, and 2). However, when the two fans were turned on together at operating speed, fan #2 appeared to have a slight increase of vibration amplitudes in all three measurement points while fan #1 amplitudes remained almost the same (Table 3). The highest amplitude appeared in the motor outboard vertical at 0.456 in/s with the dominant peak at 841 cpm which indicated a probable structural resonance vibration. Spectral data also showed no other signs mechanical problems in the system.

Recommendation: Inspect the frame structure and the dynamic absorber of fan #2. Inform the supplier about the current condition. Continue to monitor and if possible, get inside the unit while both fans are running. A bump test should be performed to further locate and analyze the resonance vibration.

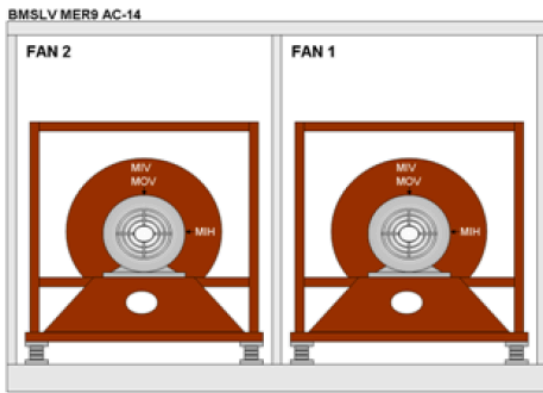
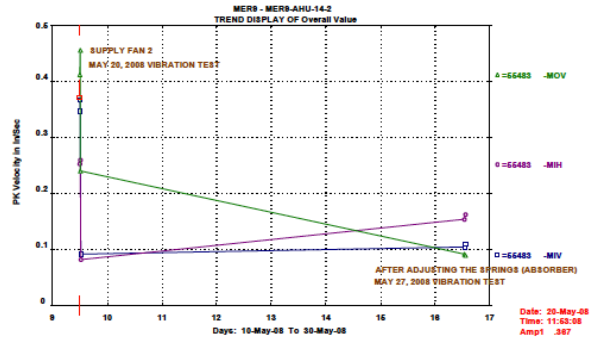
Analysis: The first vibration reading showed a significant decrease of amplitudes on supply fan #2 after adjusting its six spring absorbers, most notably from 0.45 in/s to 0.09 in/s on point MOV. However, when the damper positions of the two fans were opened 45%, 50%, and 70%, the amplitudes on supply fan #1 started to increase while the amplitudes on supply fan #2 remained steady. Subsequent readings showed reduced vibration levels on supply fan #1 when supply fan #2 was turned off. Additional bump tests and analysis were performed to look for natural frequencies that would interfere with the normal operation of the fan. No significant issues were noted.

Findings: The spring absorber loading and damper positions played a significant role in vibration levels. Most of the springs needed to be properly adjusted and any damaged ones were scheduled for repair or replacement. Once the the springs were no longer an issue, it was determined that if abnormal levels are present during future readings, the damper position should be noted and addressed if it's more than transient in nature.

Case Study Note: After another few test of running the unit at different damper settings to get the unit running on both fans, the supplier/contractor was able to get the damper position with proper flow rates they needed to run both fans. Resonant vibrations also reduced significantly upon verification of flow rates.
