## Controlling the **Silent Killers** of Strategic Asset Management

# The Role of MACHINER ACTINER

#### **CASE ANALYSIS**

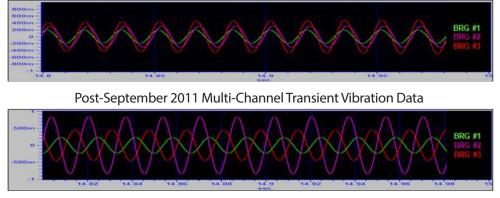
Figure 4: Time synchronous data, turbine bearings

nor inspections. This data was used as a secondary check to determine the relative phase relationship shifts between the turbine shaft bearing positions. The data was normalized to only include the 60 Hz frequency for waveform analysis of the proximity probe data. This analysis showed that prior to the September 2011 major inspection, the turbine shaft measurements were found to be in phase with each other, with significant changes observed in relative phase after the inspection.

### Pre-September 2011 Multi-Channel Transient Vibration Data

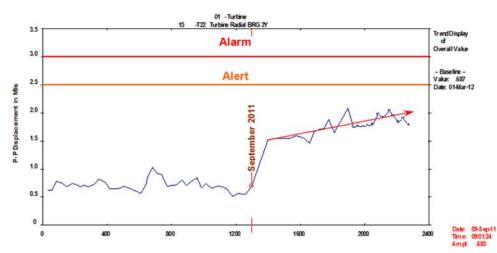
Figure 5: Condition monitoring data, turbine bearing 2

pk-pk and be in an *alarm* state if amplitudes were above 3 mils pk-pk. The historical vibration data showed amplitudes at this bearing position averaging .685 mils pk-pk, with an increase to 1.515 mils pk-pk after being put back into service in December 2011.

The final analysis of the system's newly established vibration amplitudes, frequency distribution and phase reference data indicated the turbine shaft's bearing alignment was not within specification after the September 2011 major inspection. This information was relayed to plant maintenance and operations personnel for consideration. An internal review of the turbine's bearing inspection showed that the #2 turbine bearing housing was "adjusted" by the contractor who provided the major inspection services for the facility's outage. This adjustment to the bearing housing's horizontal position was isolated as the root cause for the increase in vibration amplitudes and phase changes noted for the machine after the September 2011 inspection.

not warrant a system shutdown to incorporate the repairs necessary for returning the turbine's bearing alignments back to within specification. By catching and isolating the cause for increased vibration levels in the #2 turbine bearing after the facility's initial start-up, the plant's reliability and maintenance departments were able to make accommodations for performing a precision bore alignment through the entire machine train at the next scheduled major inspection, which has a six to seven year periodicity.

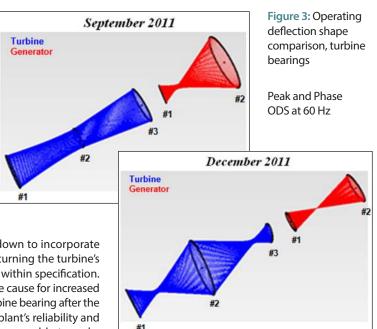
By reviewing the machine's archived data snapshots, technicians were able to produce orbit-based animations for comparative operating deflection shape (ODS) analysis that included all the radial proximity probe data. These comparisons allowed for common scaling of all the bearing positions monitored, resulting in a visual representation of the turbine and generator shaft vibration amplitudes and phase relationships. This ODS analysis clearly showed the #2 turbine bearing's relative increase in amplitude after the September 2011 major inspection and also indicated a phase relationship change across the turbine shaft.
