Title: Electrical Discharge Machining in DC Motors

Industry: Steel | Machine: Roll Stand DC Motors | Technology: Vibration Analysis

Purpose: This case study highlights the process involved with identifying motor bearing defects created by Electrical Discharge Machining (EDM) as the root cause of ongoing failure of DC motors that were powering Roll Stands at a Steel Mill, as well as the subsequent setting of specific fault alarms in both vibration and shaft voltage levels.

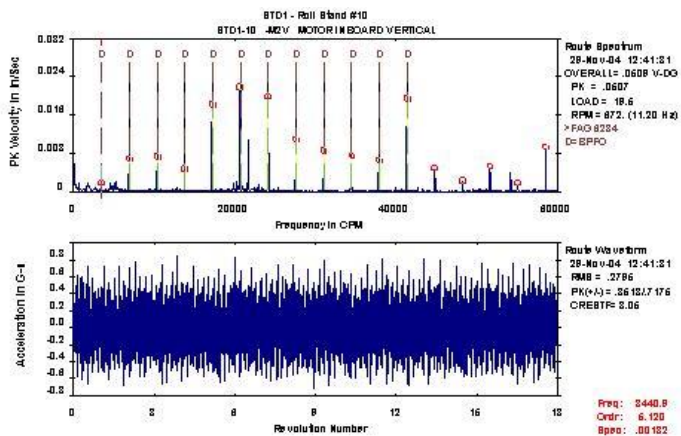
Figure 1: Baseline STND Vibration

Findings: There were a total of 28 DC motors at this facility, ranging from 500 to 1000 HP. Baseline readings showed that a large number of the motors had BPFO present at low amplitudes in the standard vibration Spectrums (**Figure 1**), significant BPFO & Waveform impacting in the PKVue Data (**Figure 2**), and elevated HFD values (**Figure 3**).

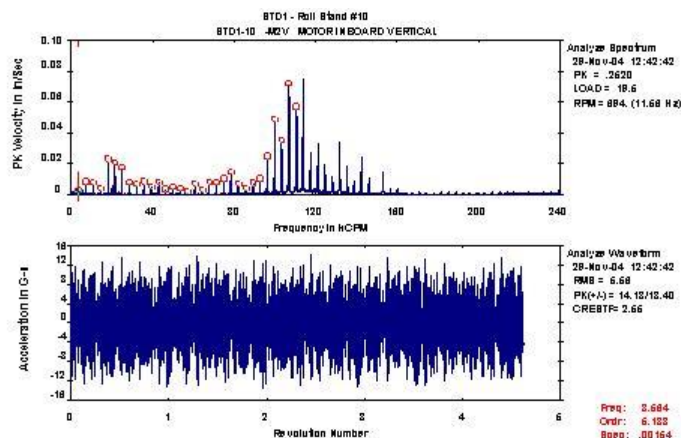
Figure 3: Baseline High Frequency

These baselines triggered the need for a quick look at the high frequency ranges, which produced some rather dramatic results around 120k CPM.

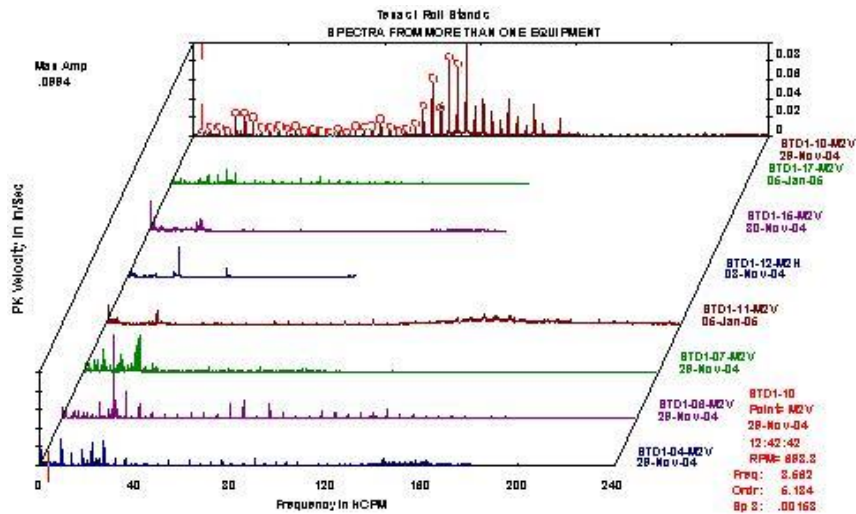
Figure 4: Baseline High Frequency Data Comparison

Based solely on the baseline data, one could determine that Electrical Discharge Machining (EDM or Fluting) was occurring in some of the motors. An in-depth look at all the high frequency Spectrums gathered during the baseline survey (**Figure 4**) helped to isolate the motor with the highest amplitudes, thereby giving us an idea as to where the high frequency bandwidth alarms should be set. At this time, a work request to replace the most effected motor was submitted to the customer.

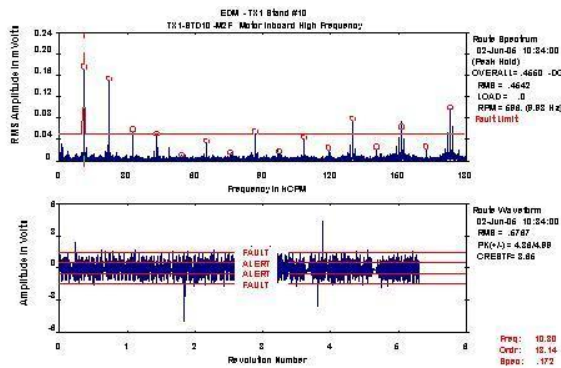
Figure 7: EDM Trend 1

Now being monitored with very specific fault alarms (both in vibration & shaft voltage levels), the new data trends (**Figures 7 and 8**) completely substantiated the fact that a severe defect was present in the motor in question.

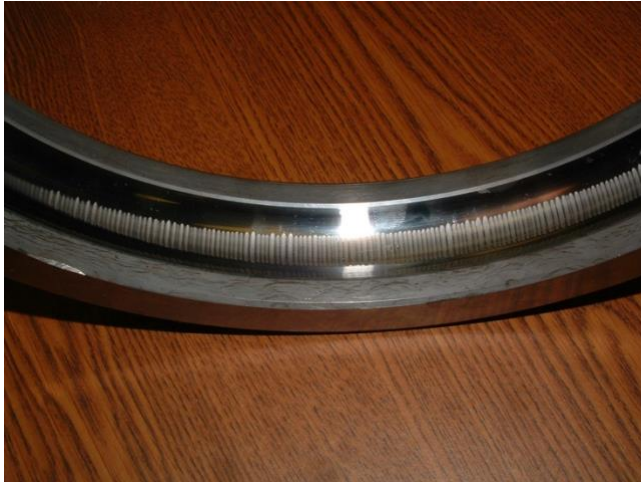
Figure 13: STD 10 EDM

Once the bearings from the old motor were returned to the plant, EDM was confirmed as the root cause for the bearing defect (**Figure 13 and 14**). The long-term solution to prevent this failure mode from occurring again was to implement better grounding devices and change the bearing types used in these motors. The implementation of these two strategies has subsequently eliminated EDM driven failures in these motors and subsequently lessened the need to continue utilizing route-based measurements specifically used to target EDM occurrences.
